TEST REPORT

REPORT NUMBER: 3188456COQ-004
ORIGINAL ISSUE DATE: November 18, 2009
REVISED DATE: December 8, 2009

PRODUCT EVALUATED: 2x4 Wood Stud and OSB Wall Coated with
"DC333" EVALUATION PROPERTY: Fire Resistance

Report of testing a 2x4 wood stud and OSB wall coated with "DC333" for compliance with the applicable requirements of the following criteria: ASTM E119 and CAN/ULC S101-04, Standard Test Methods for Fire Tests of Building Construction and Materials.

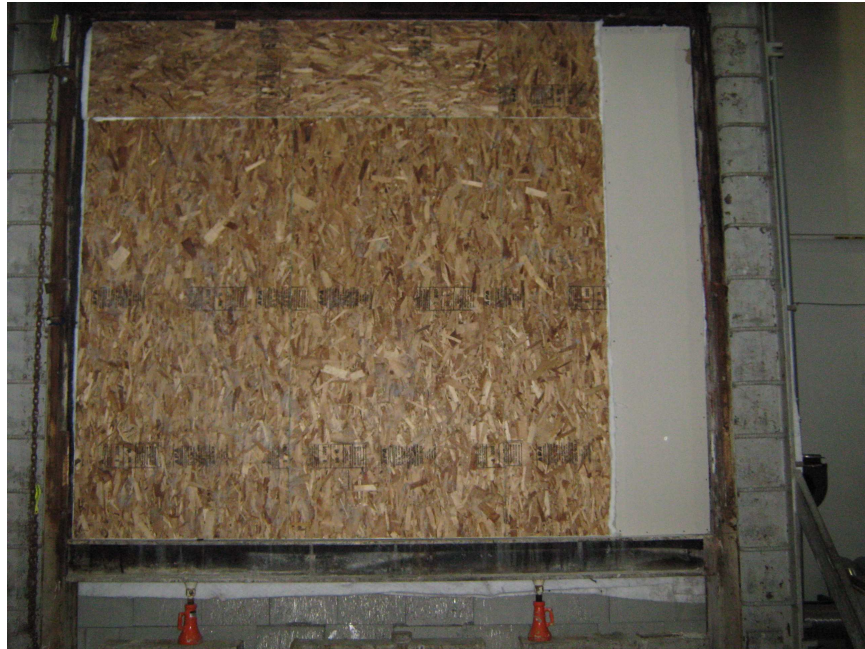
Unexposed Side Prior to the Fire Test

The test wall assembly was mounted in the full-scale vertical furnace mounting frame. Additional gypsum wallboard and steel studs were used to complete the test frame width of 12 ft., and the assembly was clamped to the front of the test furnace. See Appendix A – Photographs.

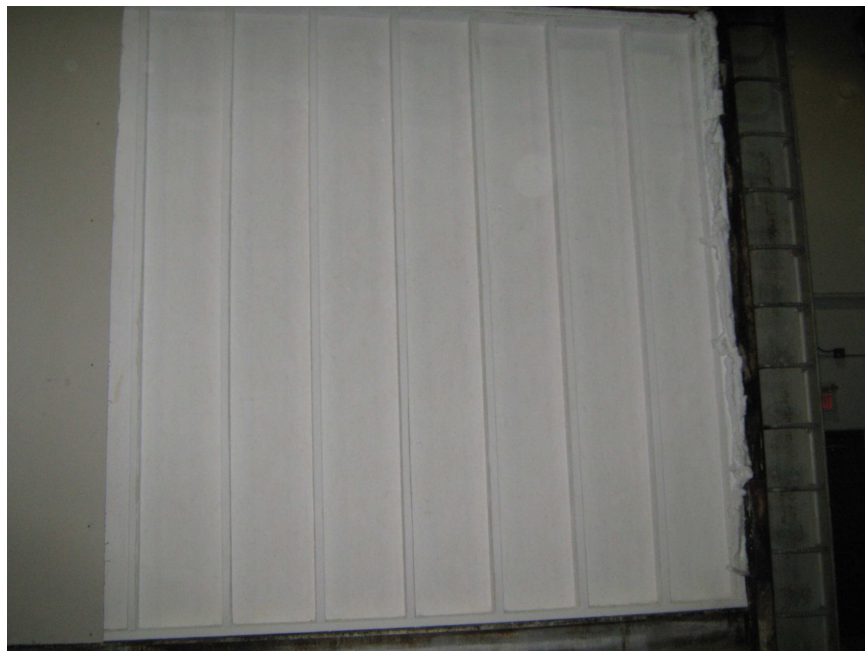
Exposed Side Prior to the Fire Test

The wall dimensions were 10 ft. wide by 10 ft. high and constructed using nominal 2 in. by 4 in. wood studs, located 16 in. on centre with a single bottom plate and double top plate. The wall sheathing consisted of standard 3/8 in. thick OSB installed with the long dimension in the vertical orientation, 1/16 in. spacing between the horizontal joints and fastened with 2 in. common nails spaced 8 in. on centre. The finished wall system contained one horizontal joint located 2 ft. from the top of the panels. The "DC 333" intumescent paint was applied to the wall by the client on November 3, 2009 to a thickness of 15 mils (wet). The wall was then left to cure until the test date.

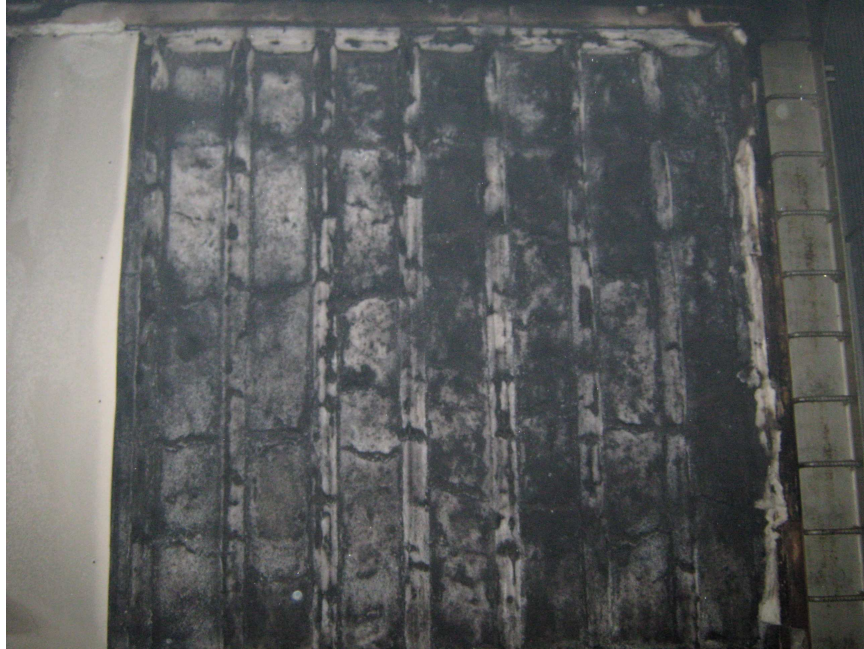
Exposed Side After the Fire Test

Time (min.)	Exposed Side	Unexposed Side
1:40	Studs are discoloring	
2:30	Coating is intumescent	
4:30	Surface ignition on studs	
6:15	Surface ignition of wall	No change
11:00	No change	
12:00	Surface has re-ignited	
14:48		Pin hole appearing
15:00	Test discontinued

The OSB appeared to be undamaged after the 15 minute test duration. All joints remained in tact and the firestop material remained in place.

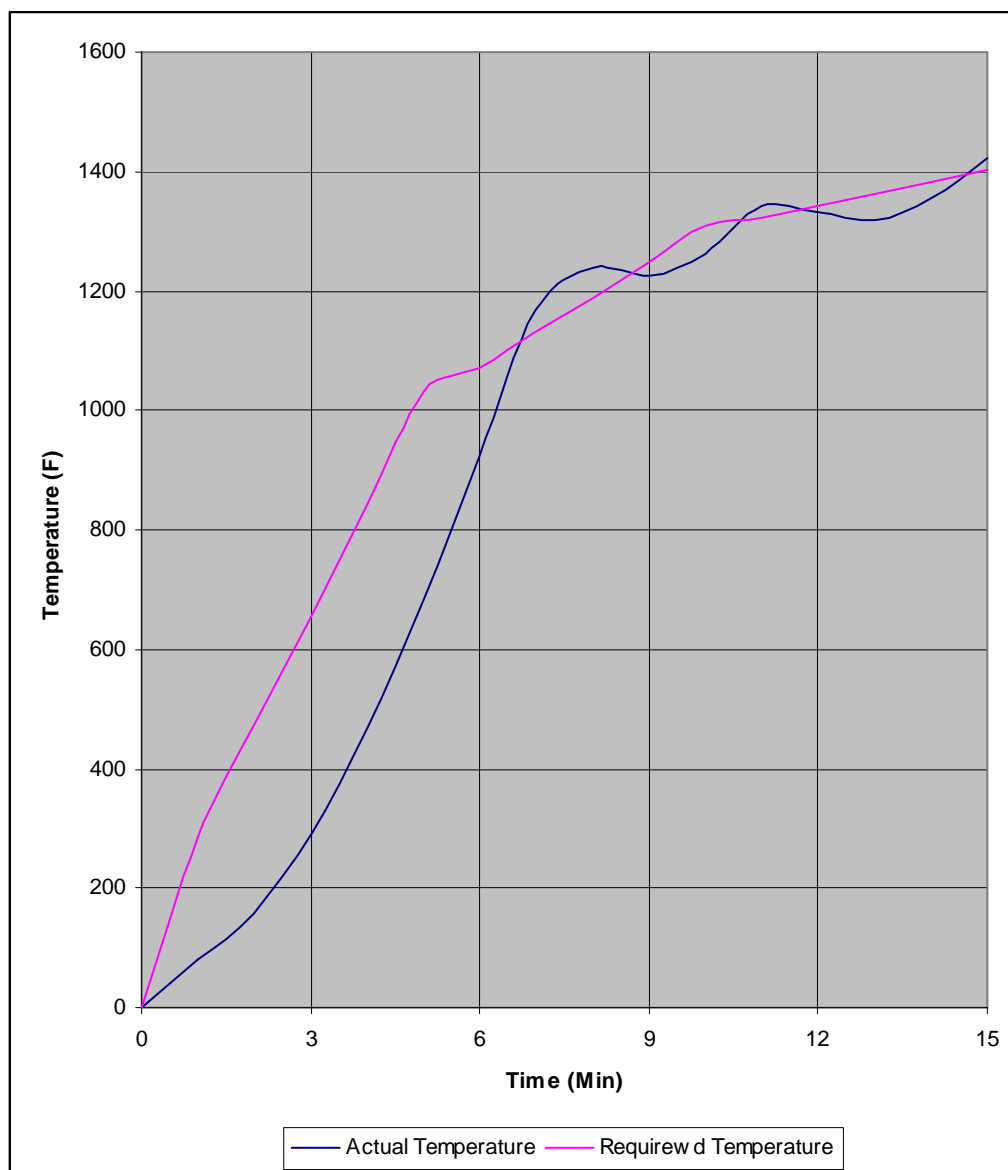
Temperature Data

TIME TEMPERATURE CURVE AVERAGE TEMPERATURE OF FURNACE DURING THE FIRE TEST

The temperatures inside the furnace are monitored by nine equally spaced thermocouples. These readings were recorded by a calibrated Fluke "Hydra Data Bucket" automatic data recorder every 1 minute and automatically displayed every 15 seconds. See Appendix B – Temperature Data.

The wall assembly was subjected to the standard time/temperature curve of CAN/ULC S101-04 and the exposed surface was observed. The test was continued for 15 minutes.
