Test Report No: TJ6783-1 Report Date: October 29, 2019

SAMPLE ID: Exposed spray-applied polyurethane foam and wood stud assembly coated with 24 mils

wet film thickness DC315, installed with ½ inch gypsum wallboard.

ASTM E119-16a, "Standard Test Methods for Fire Tests of Building Construction and Materials" (ASTM E119).

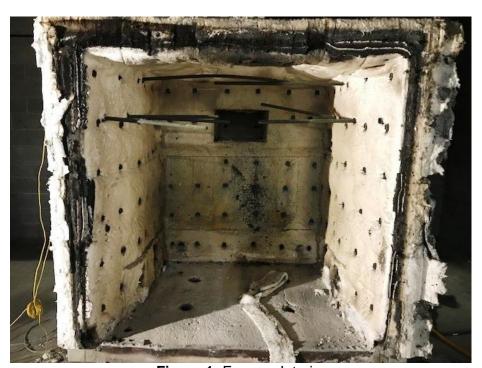
Figure 1: Furnace Interior

The furnace used in the tests is a pilot-scale fire burning apparatus with interior dimensions of 60 in. in height, 60 in. in width, and 52 in. in depth.

Temperatures within the furnace were monitored using four thermocouples. The temperatures are controlled by adjusting fuel to the furnace burners to conform to the time/temperature curve specified by the test standards.

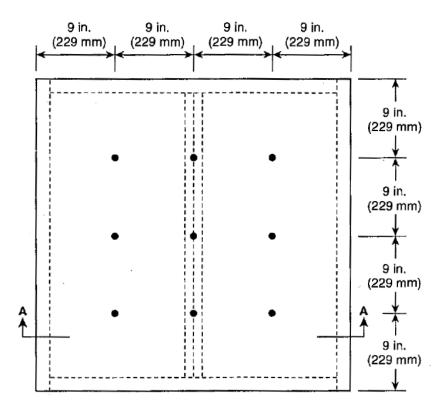
Figure 2. Thermocouple Locations

Nine thermocouples were used in this test and placed on the unexposed surface of the test sample as indicated by Figure 2. below:

Unexposed temperatures were monitored by thermocouples (TCs). The TC's were placed at nine locations per section 7.3.1.2 of the referenced standard. The temperatures were recorded continuously for the duration of the test, and the temperature rise data are provided graphically in Figure 5 and 6 in Appendix A.

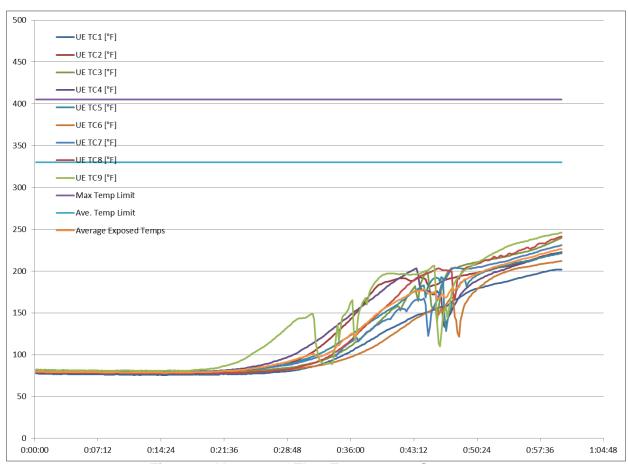
Figure 4: Unexposed Time Temperature Curves

NOTE – The displayed temperatures became detached from sample and were reattached mid test to the same location, causing drop of temperature. As the time during thermocouple drop were not within the allowable non fire side temperatures, the results are not considered to effect the results contained in this report

The maximum temperature limit of 325°F above initial was not reached for the tested assembly during the 60 minutes test.

The average temperature limit of 250°F above initial was not reached for the tested assembly during the 60 minutes test.
